Preliminary Results of Post-Disaster Archaeological Investigations at the Vatsala Temple and within Bhaktapur's Durbar Square, Kathmandu Valley UNESCO World Heritage Property (Nepal)

Coningham, R.A.E.¹, Acharya, K.P.², Davis, C.E.¹, Kunwar, R.B.³, Tremblay, J.C.¹, Schmidt, A.¹ and Simpson, I.⁴

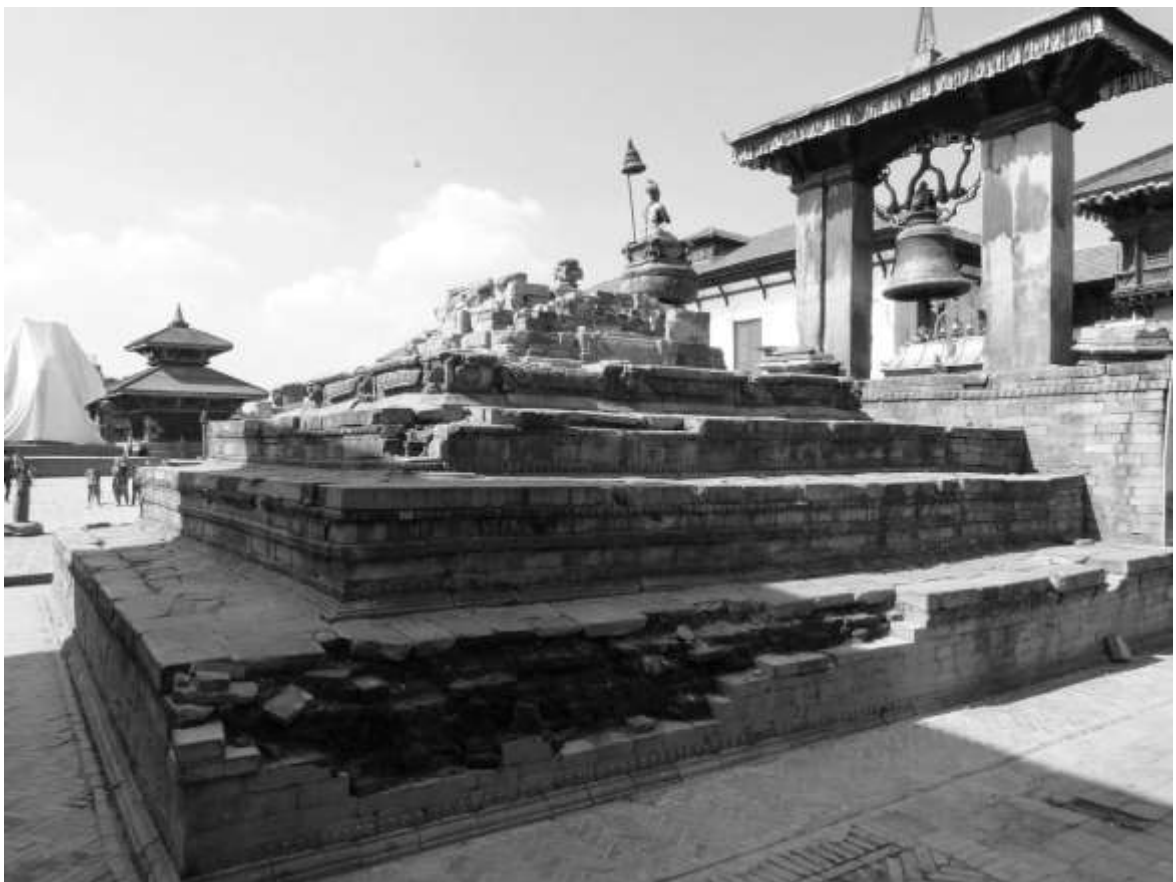
The excavations on and adjacent to the Vatsala Temple in Trenches 1A and 1B have provided an understanding of the construction technique and phasing of the monument as well as some reasons as to why the monument may have collapsed in the earthquake of the 25th April 2015. Once loose material was removed, it was clear that the stone blocks were only cladding, not keyed in or mortared to each other or the underlying brickwork and belonged to a later construction phase. Currently, we cannot ascertain whether this was relatively soon after the construction of the brick core or sometime after but the evidence points towards two quite separate phases. This lack of bonding and the weight of stone blocks for the cladding possibly left the Vatsala Temple open to the displaced masonry earthquake damage. Indeed, unlike many monuments that were damaged in 1934 and not in 2015 or vice versa, the Vatsala Temple has now been badly damaged in both seismic events, suggesting a structural flaw in the interface between the monument's superstructure and foundations.

Figure 4: The collapsed Vatsala Temple on surviving plinth.

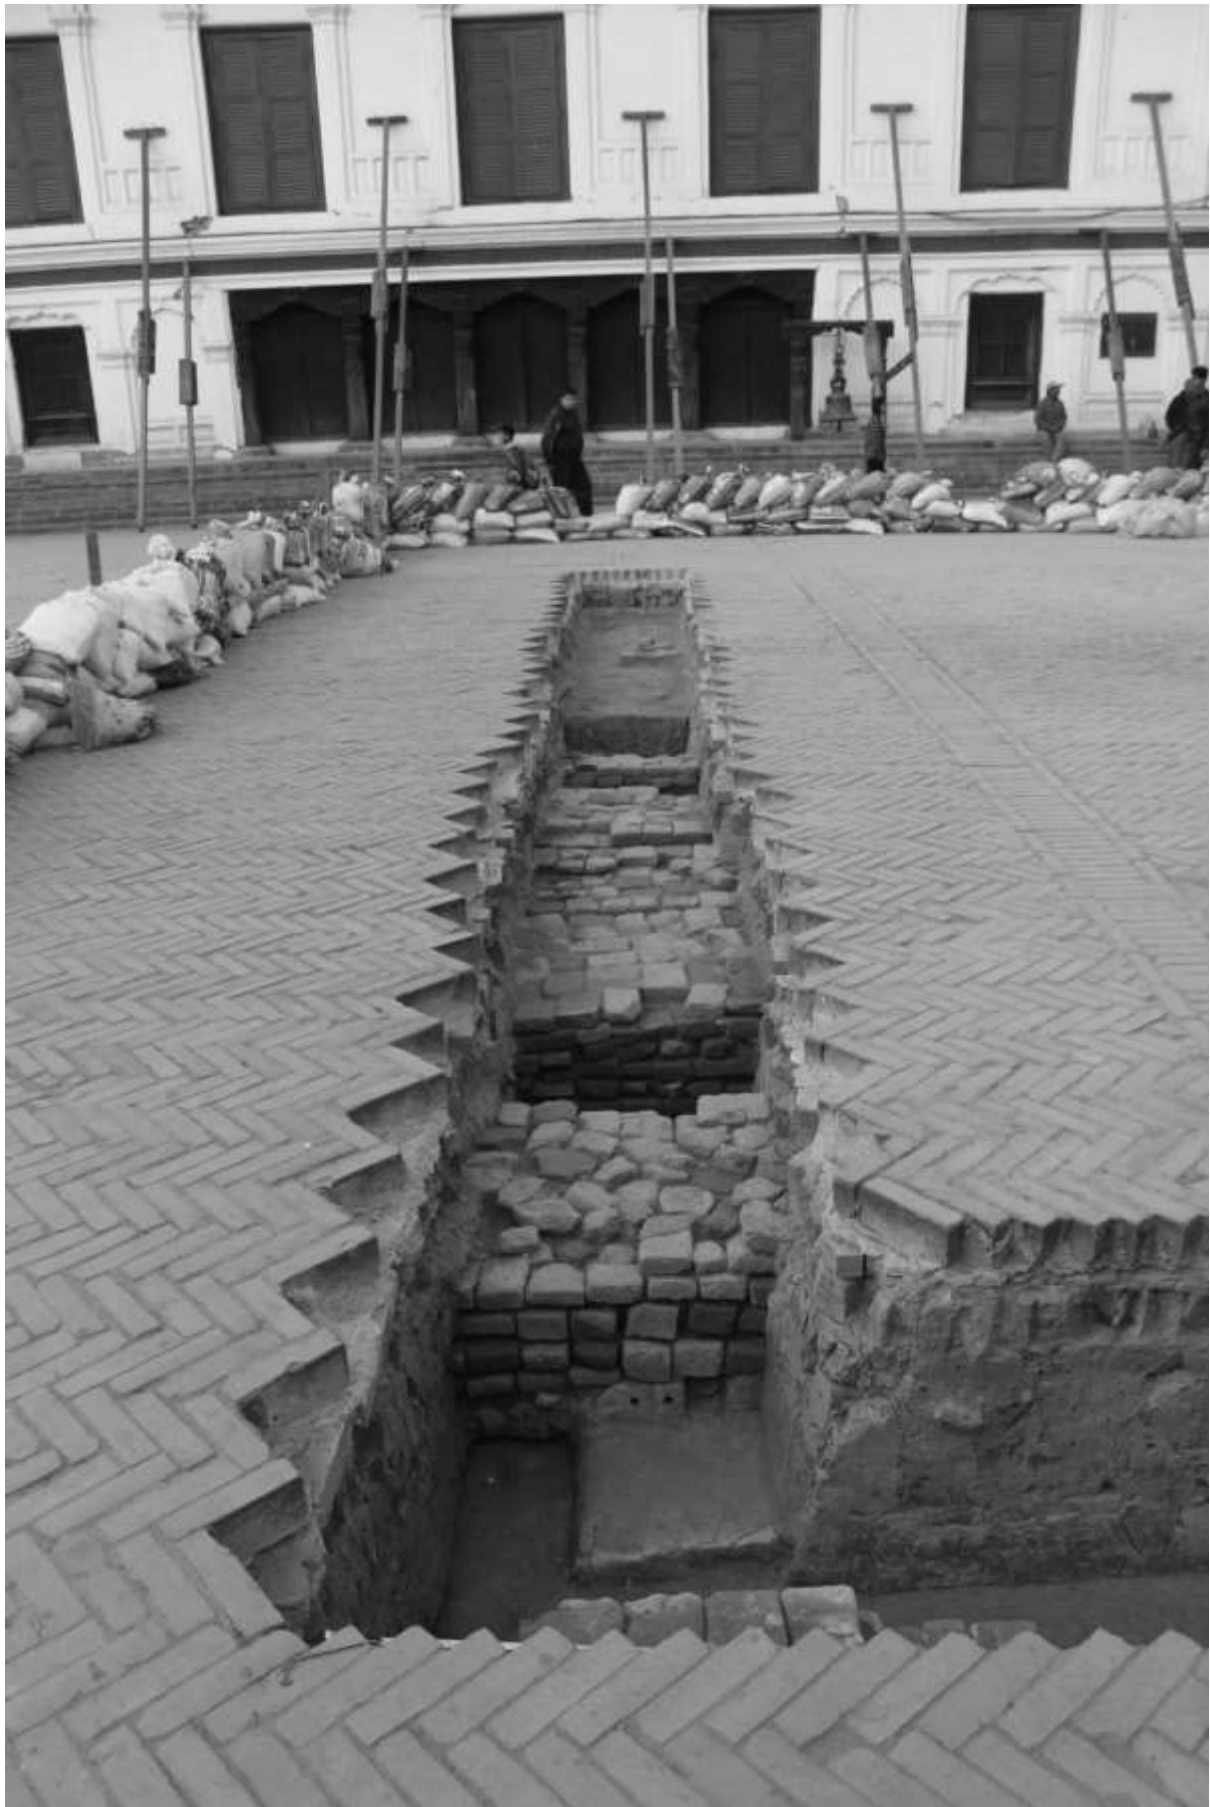
Six walls were also identified running east-west across the trench. Constructed of brick, although the northernmost was constructed on stone foundations, these walls sat within extremely narrow cuts. The furthest south of these walls appeared to have a cut relating to a wooden post, and also appeared to be robbed out to its east. The east-west walls all appeared to cut through a very clean yellow clay material. Initially thought to be a potential natural, the material resembled a prepared floor surface. We await geoarchaeological results of both the micromorphology and scientific dating before confirming such a hypothesis, thought it would appear to be earlier due to the intrusive nature of the wall cuts.

Figure 7: Wall alignments running east-west across Trench 1, looking north.

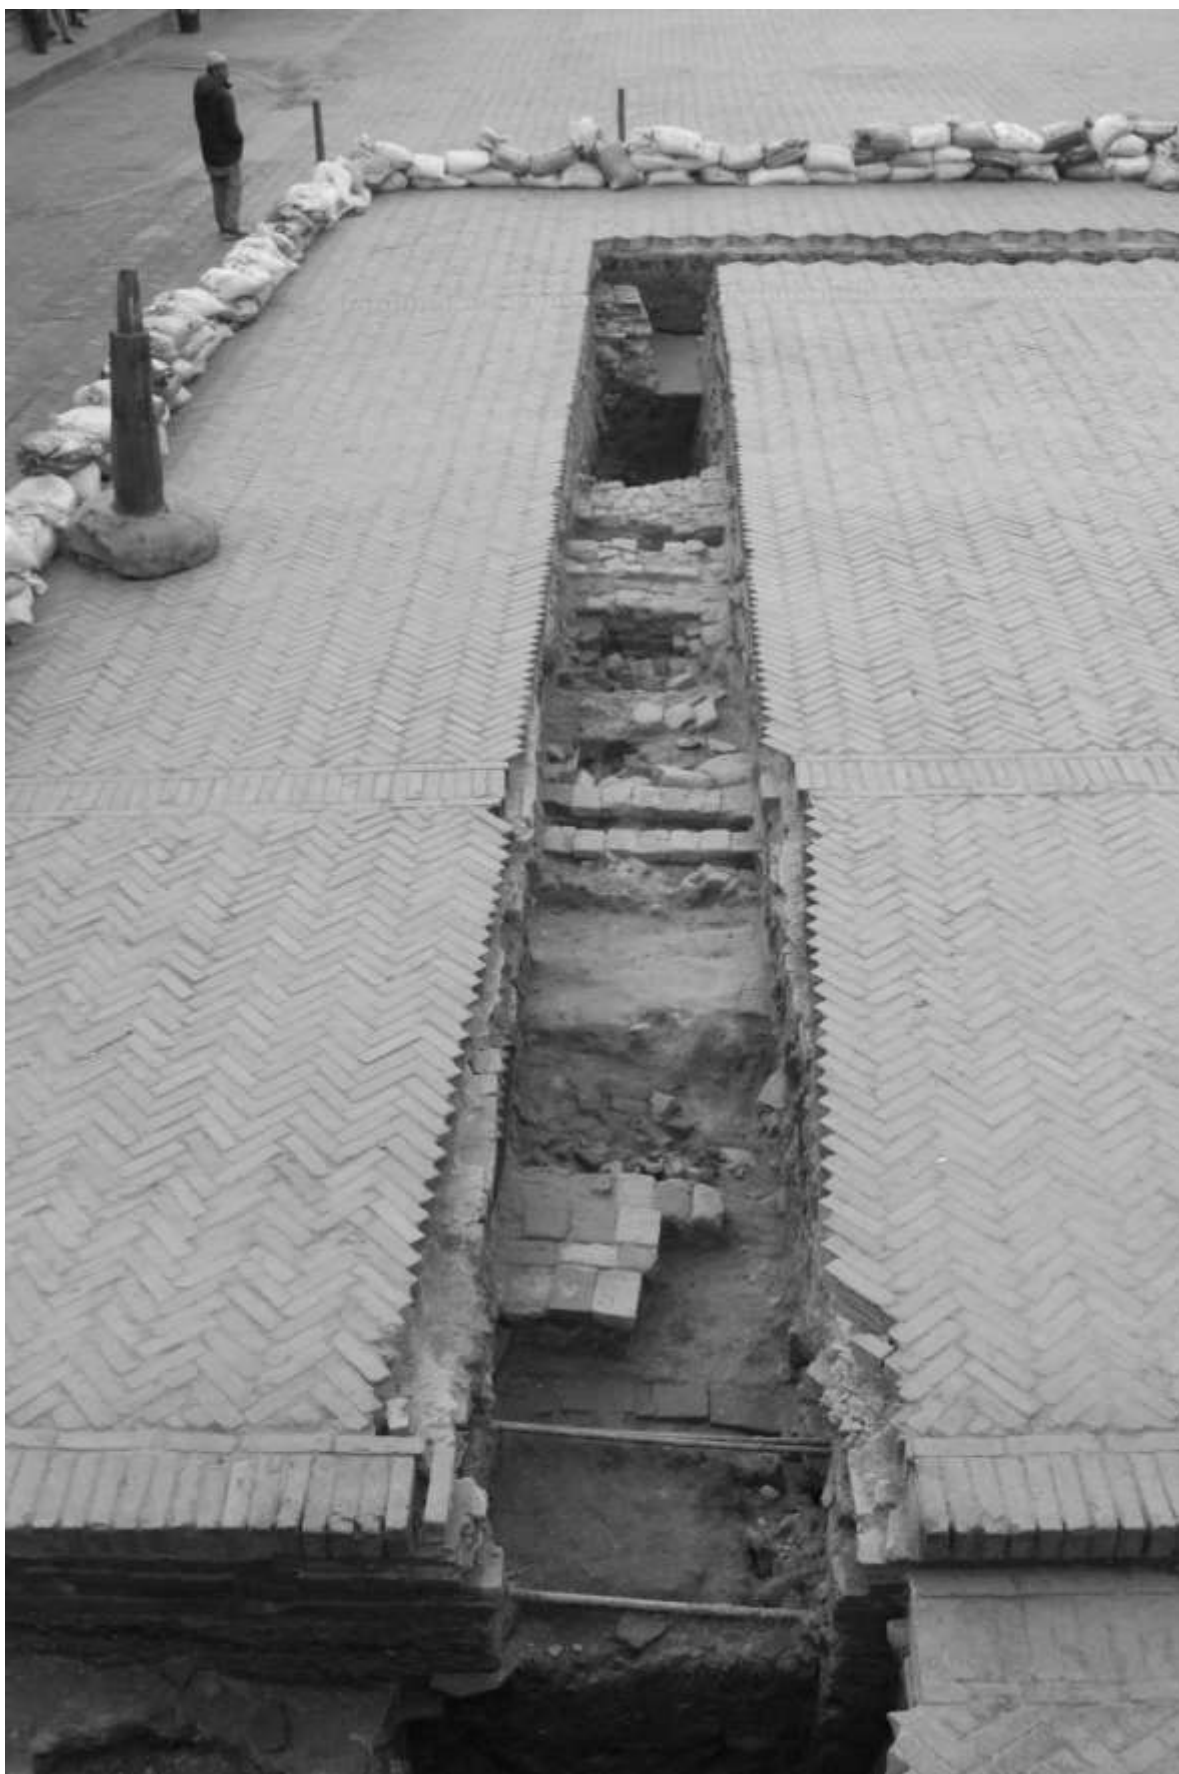
The GPR and excavations clearly show the historic structures within the square, which lay below the current brick paving. Unfortunately, our investigations have also shown that one of the key features identified were modern pipelines running through the square, which we have clearly demonstrated have cut through earlier archaeological stratigraphy. Due to the high concentration of subsurface heritage at Bhaktapur, such modern interventions are a concern as the laying of any infrastructure has the potential to damage and destroy subsurface heritage of this site of Outstanding Universal Value.

Figure 8: Masonry features running north-south across Trench 1, looking west. Also note the modern pipelines running across the trench in the foreground.

The damage caused by the 2015 earthquakes will require reconstruction and also the repair and laying of amenities in Bhaktapur. Whilst we do not recommend the suspension of the laying services and reconstruction, we do advocate the mobilisation of rescue archaeology teams to undertake rescue excavations in advance of interventions (Coningham et al. 2016b). The Archaeological Risk Map for Bhaktapur will provide information for site managers and stakeholders for the risk posed to subsurface heritage and help guide future development (Figure 25). From our observations and investigations, we feel there needs to

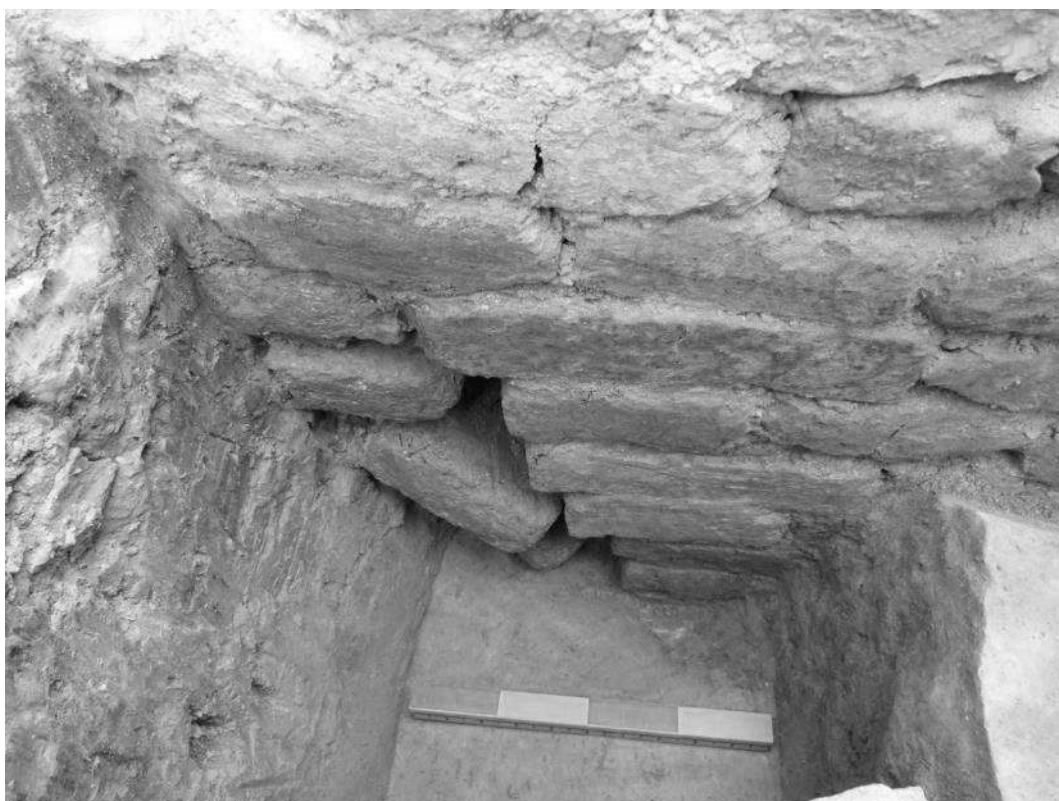
Also running north-south across the trench, was a defined surface of smaller squared bricks. Again, initially thought to be a wall, excavation revealed that this feature was one course thick and actually represented another paved area (Figure 9). Several walls were identified in the trench that also ran on a north-south alignment. To the east of the paving and west of the drain were two wall alignments, very close together. Due to their proximity and the leaving of the walls in situ during this pilot season, we could only identify eleven courses of brick, but several more were probable. We also identified potential signs of penetrative fractures or shear cracks within the west-facing elevation of the more western wall (Figure 10), which is one of the key classifications of Earthquake Archaeological Effects (EAW) that can be identified in the archaeological record (Giner-Robles et al. 2009: 13). The wall to the east of this appeared to be cracked and had a split running north-south across the alignment. The wall was tilted and displaced to the east and also was associated with a brick scatter, probably relating to a wall collapse (Figure 11). These indicators on these two

walls suggest evidence of damage caused by earlier earthquakes, most likely relating to the events of 1934.

Figure 10: Shear crack of wall within Trench 1 indicating possible earthquake damage.

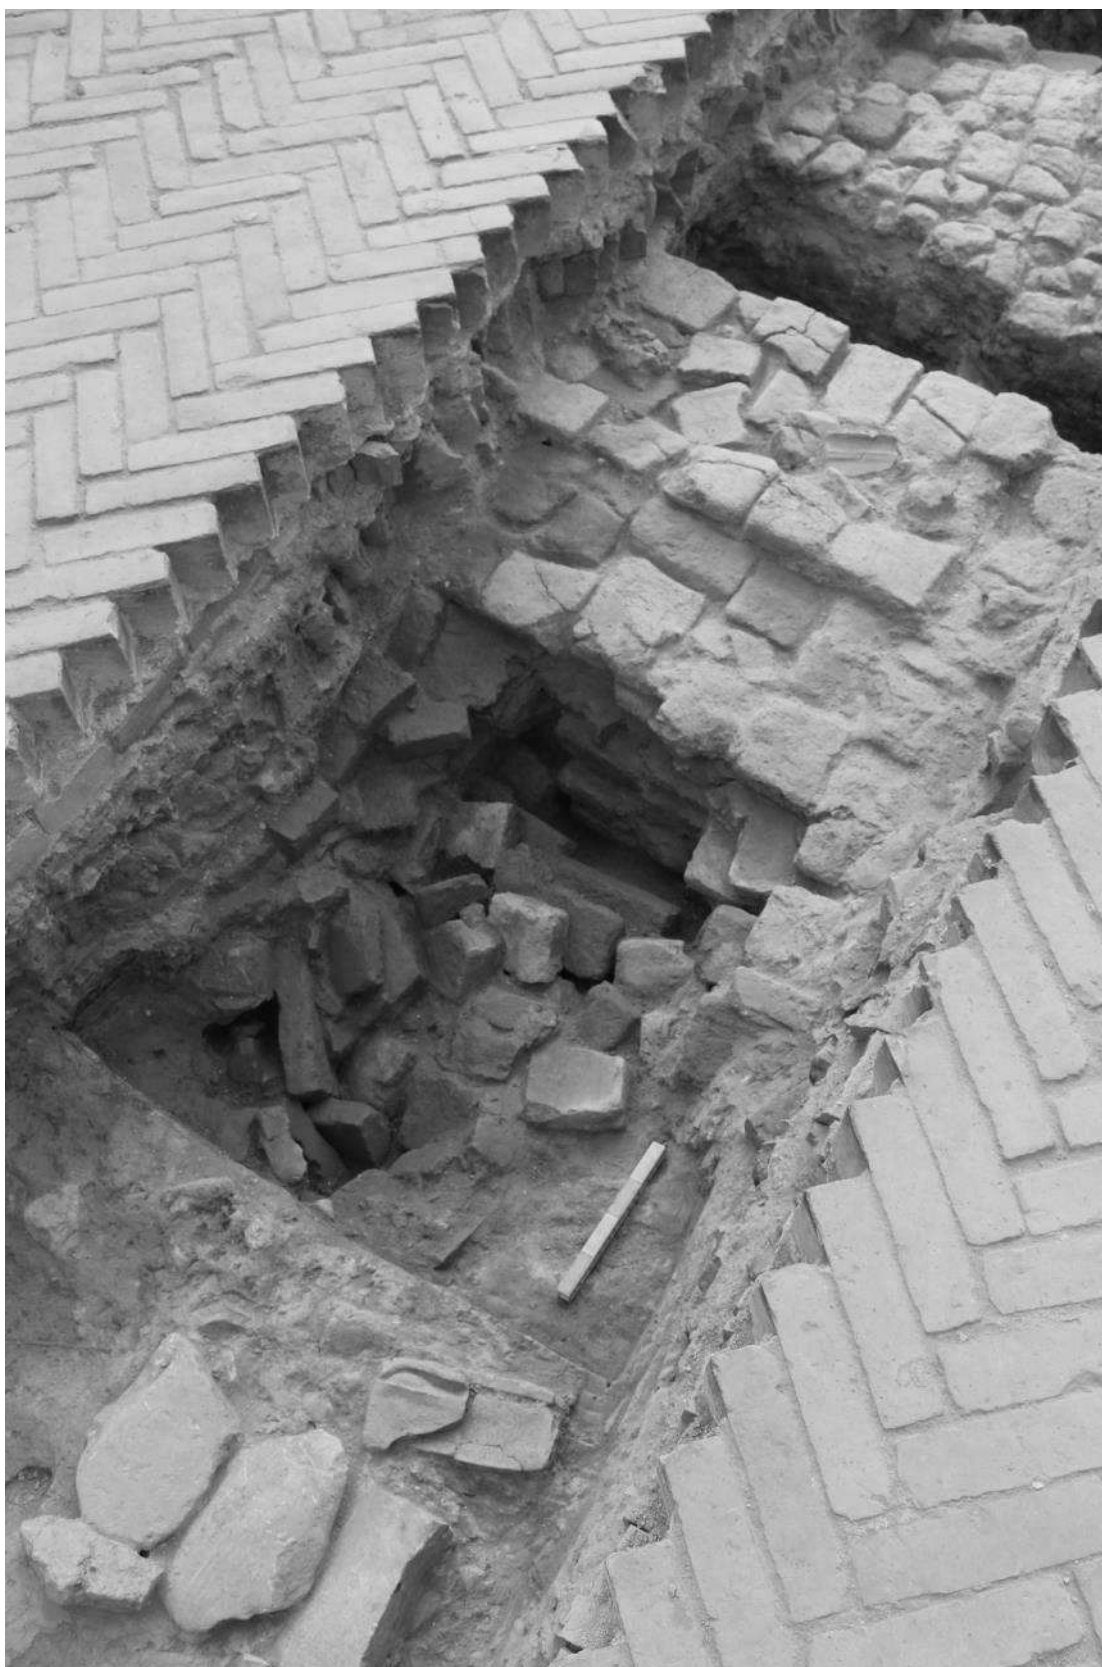
Figure 11: Wall collapse in Trench 1, indicating possible earthquake damage, looking south west.

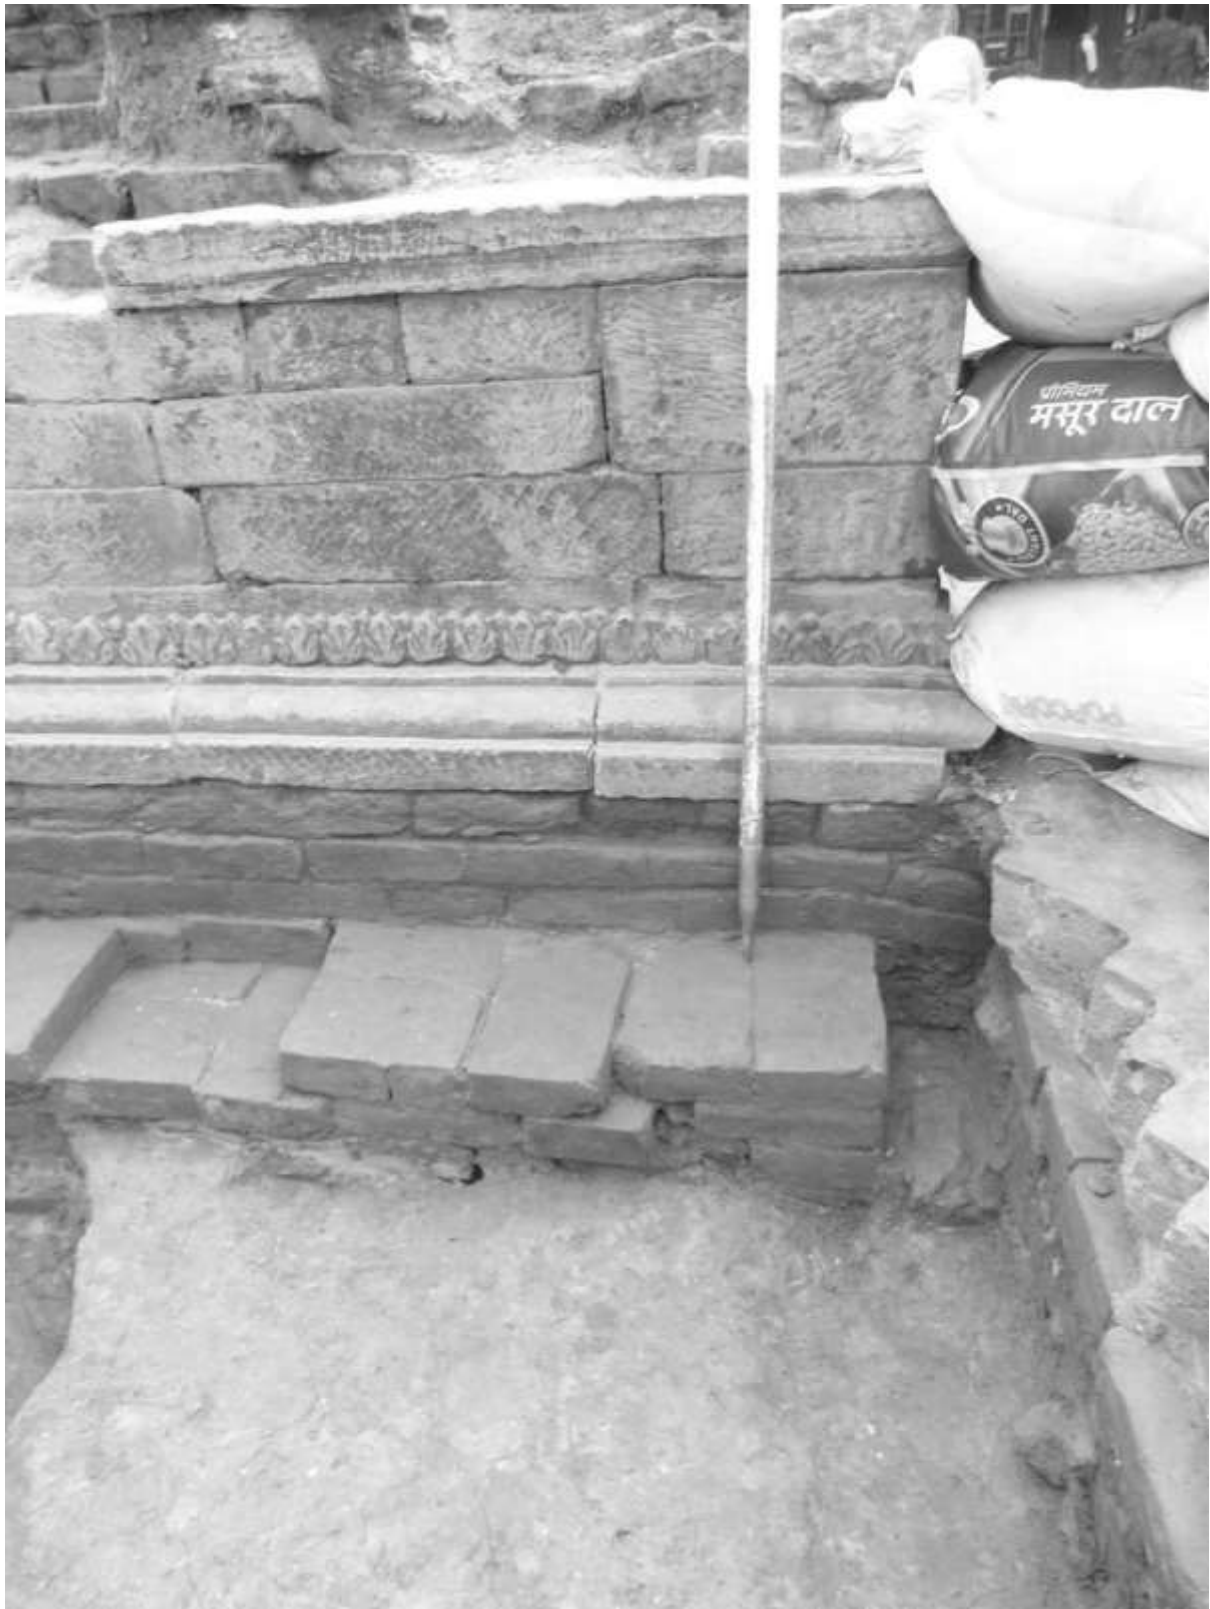
Figure 13: Later brick courses overlying earlier footprint of the Vatsala Temple at the south-west corner.

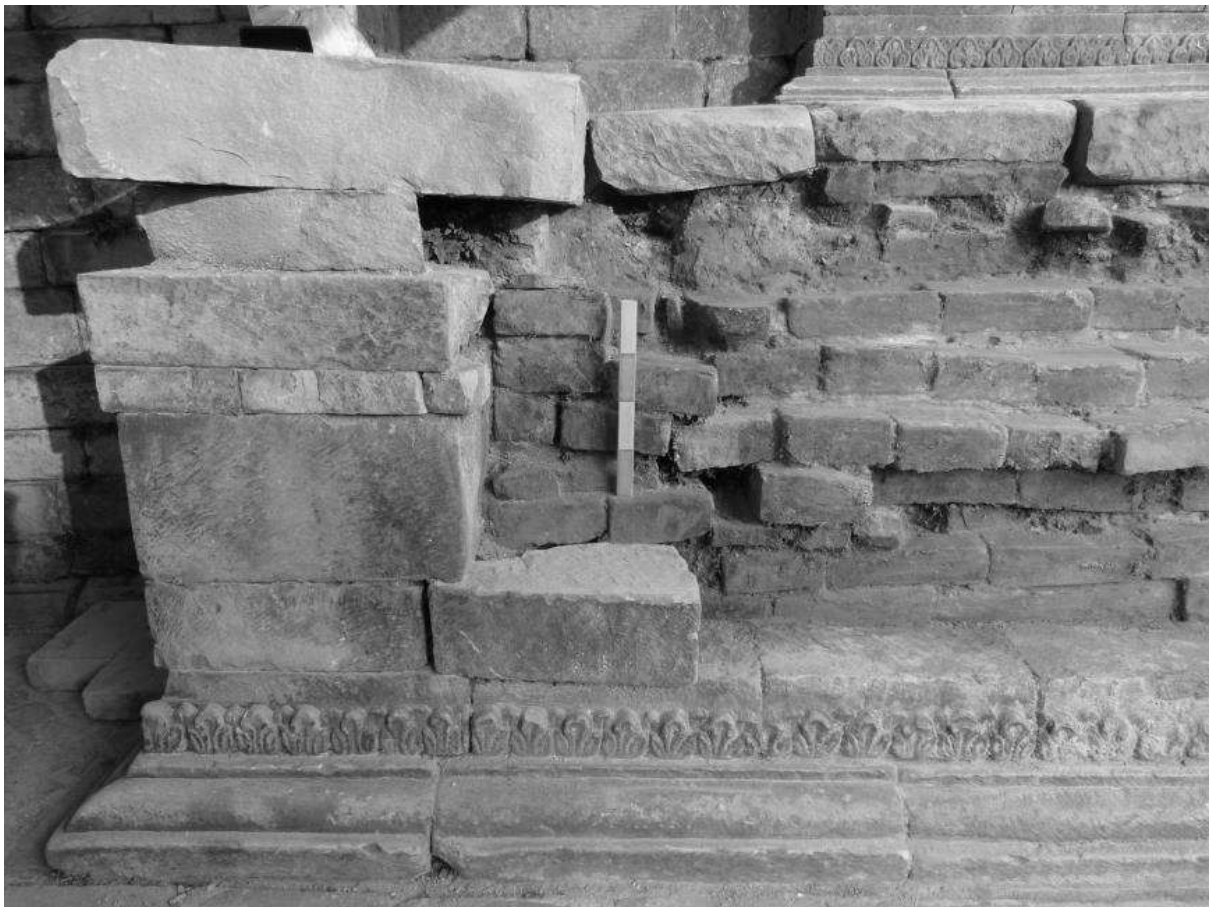
Trench 1B related to the clearing of loose material from the lower stone plinth of the Vatsala Temple, to the north of the central steps in the west facing elevation. Below the loose worked stone blocks was a pale loose clay, which contained small chipped fragments of stone that we believe are from the working of the blocks. The large stone blocks were not keyed into each other or the underlying brickwork, which formed the core of the Temple walls. The stone blocks were not keyed into the brickwork behind but were bonded to it through the use of clay mortar, which again contained fragments of chipped stone. Therefore, it became apparent that the stone blocks formed a later facing to the Temple's brick core and that the blocks had been brought to the site and cut to fit the brickwork rather than the other way. It would appear that the fragments of chipped stone incorporated into the clay mortar separating the two were most likely from this in situ working of the large stone block cladding. The later addition of stone cladding was further supported by the observation that the loose clay was not evenly spread but was found in denser and deeper concentrations over the underlying brickwork and that the thickness of the stone blocks were also not even, with different sized blocks used in tandem with this clay fill to provide a level surface for the stone facing (Figure 19).

Figure 19: Differing phases of construction and bonding of brick and stone block masonry in Trench 1B.

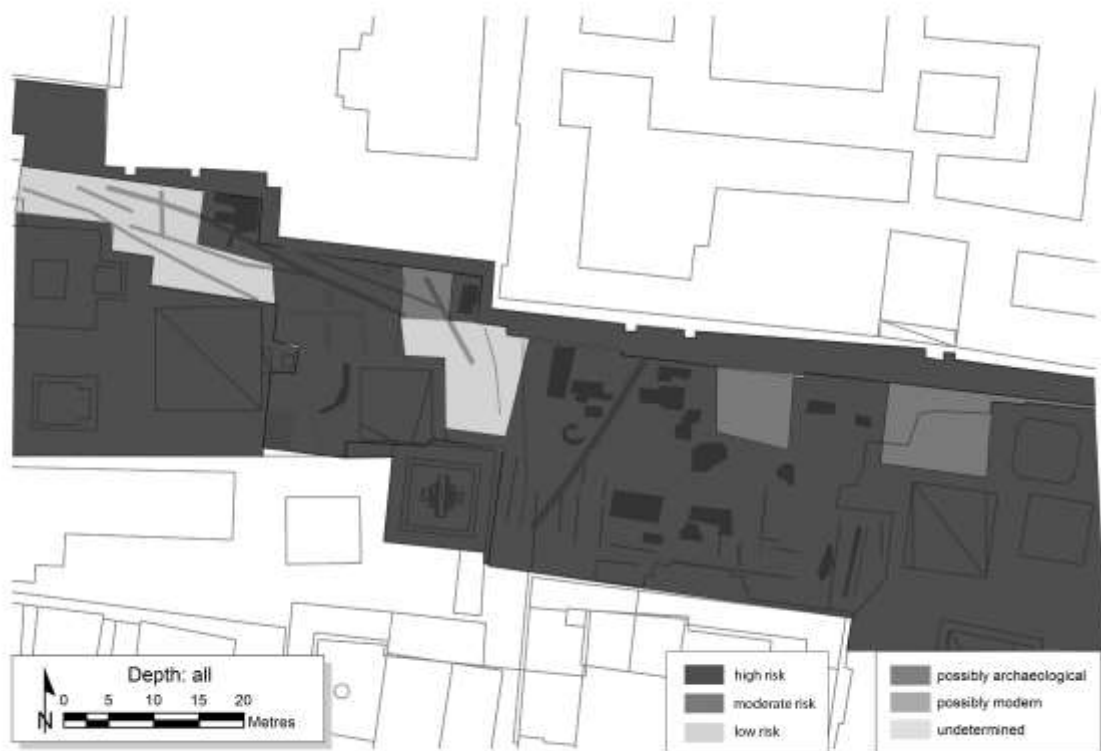
Figure 25: Provisional Archaeological Risk Map for Bhaktapur's Durbar Square.

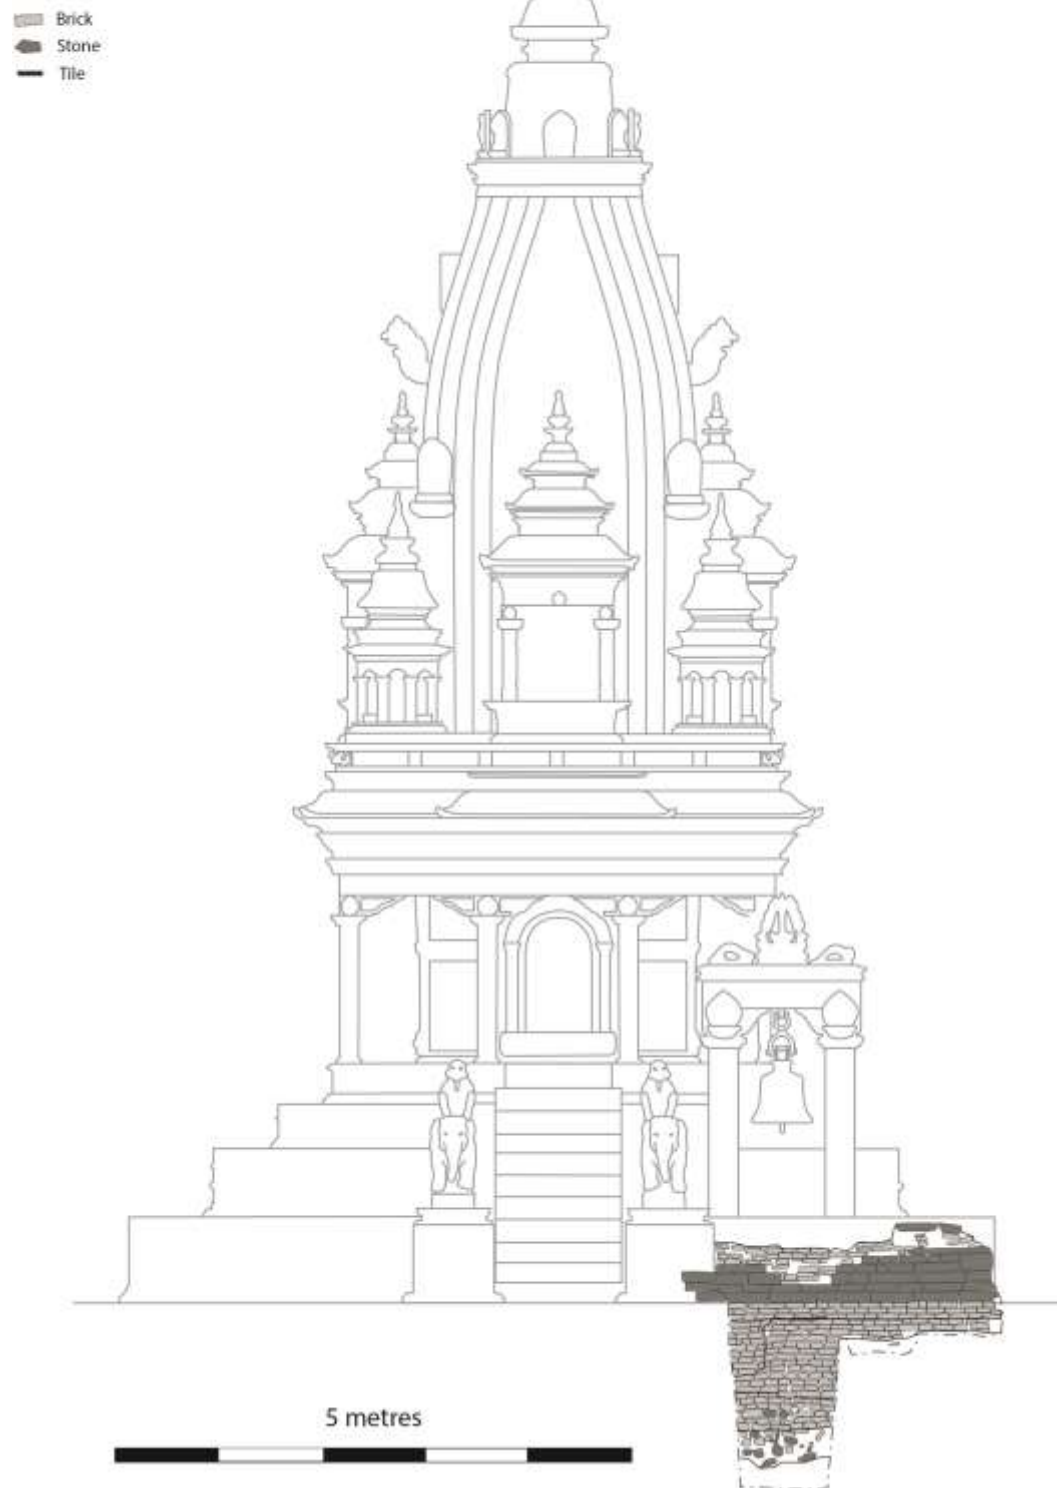
Figure 28: West facing section of Trench 1B, illustrating depth of foundations, with superimposed elevation of Vatsala Temple before collapse (Elevation of Vatsala Temple after Basukala et al. 2014).
